Inspection Report

Section: Main Roof

Overall Grade: A-

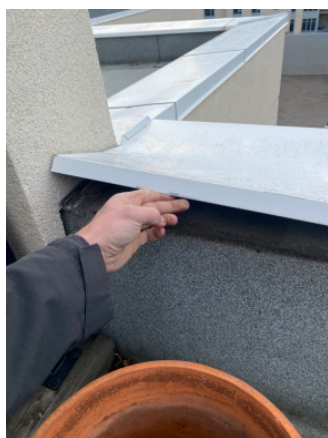
Perimeter - Metal Edge - Loose (Fasteners) (Emergency)

As the building moves and flexes the fasteners will loosen up and eventually back out completely resulting in water infiltration.

A new fastener, one size larger would be installed per industry standards to ensure a water tight seal. **Estimated Repair Cost:**

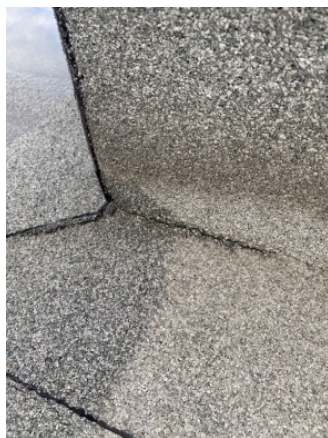
Membrane - Splits/Cracks (Emergency)

Splits/cracks in the membrane are typically due to building movement and lateral stresses. As the membrane ages and weathers, it cannot withstand these forces and split open.

The area surrounding the split must be cleaned and preped. Compatible roofing materials for the existing roof system would be installed according to minimum industry standards.

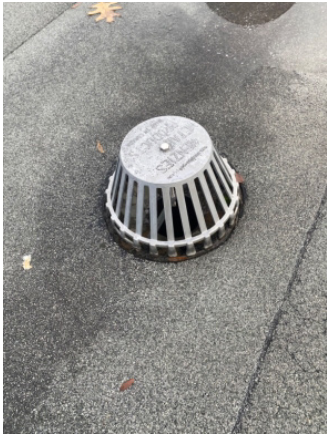
Add Liquid Membrane

Liquid membrane is either non-existent or is in need of cleaning and applying.

Clean and prep area and apply liquid membrane

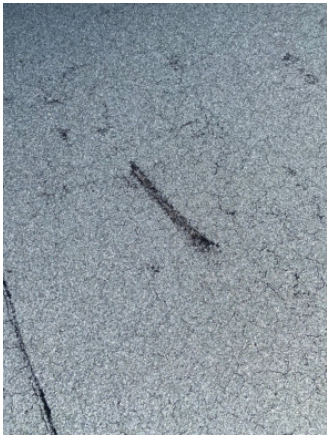
Membrane - Punctures/Rips/Tears

These deficiencies are typically caused by heavy foot traffic by other trades, careless mechanical work, careless installation processes or storm related weather events.

Clean and prep the area around the puncture, rip or tear and repair according to the existing type of roof system meeting the minimum industry standards for the type of repair needed.

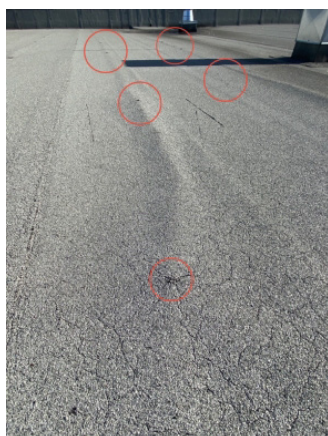
Membrane - Holes (Emergency)

Holes caused by nails backing out of base sheet membrane.

Cut ridge out of membrane, fasten cap sheet membrane, Install new base membrane and New cap sheet membrane as per manufactures requirements.

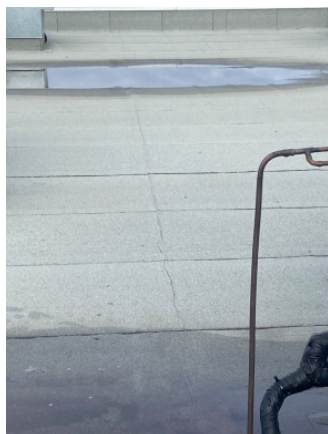
Membrane - Splits/Cracks (Emergency)

Splits/cracks in the membrane are typically due to building movement and lateral stresses. As the membrane ages and weathers, it cannot withstand these forces and split open.

The area surrounding the split must be cleaned and preped. Compatible roofing materials for the existing roof system would be installed according to minimum industry standards.

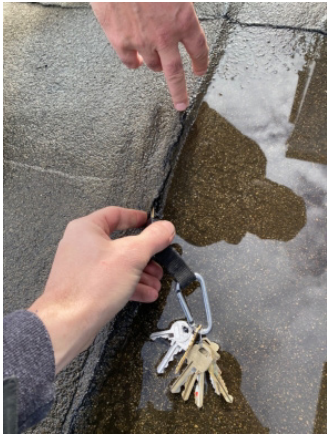
Membrane - Splits/Cracks (Emergency)

Splits/cracks in the membrane are typically due to building movement and lateral stresses. As the membrane ages and weathers, it cannot withstand these forces and split open.

The area surrounding the split must be cleaned and preped. Compatible roofing materials for the existing roof system would be installed according to minimum industry standards.

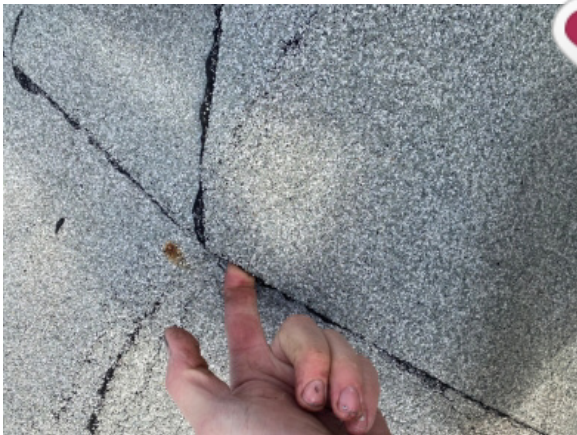
Membrane - Fish Mouth in Corner (Emergency) Quantity:

Example of fish mouths on membrane laps that is allowing water into the system.

We will cut the fish mouth out, clean and prime the area and install new patch over effected area to ensure water tightness.

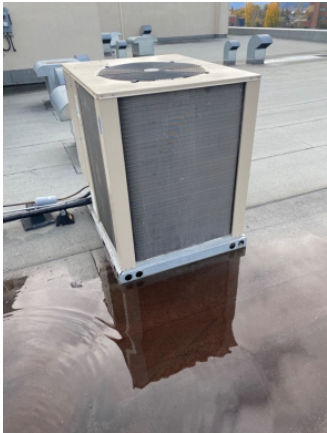
New - Curb Installation

Supports need to be installed under rooftop unit to limit damage to roof membrane and allow for positive drainage.

Install new wood sleepers. Seal curb with new roof membrane as per manufacturers general requirements.

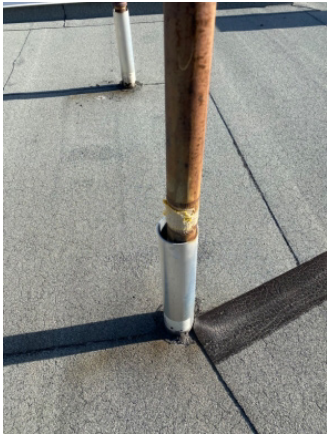
Penetration - Pipe flashing failure (Emergency)

Due to age, weathering, UV &/or improper installation the penetration flashing has failed.

The pipe penetration should be repaired/flashed properly for the type of roof system per minimum industry standards to ensure a water tight seal.

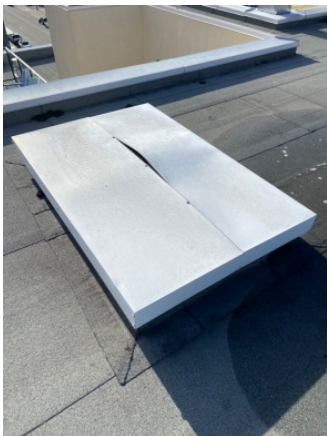
New Metal Cap and counter flashing (Emergency)

Metal cover allows water ingress.

Supply and Install New Solid Metal Cap. Plywood may need to be replaced if rotted out. Plywood not included

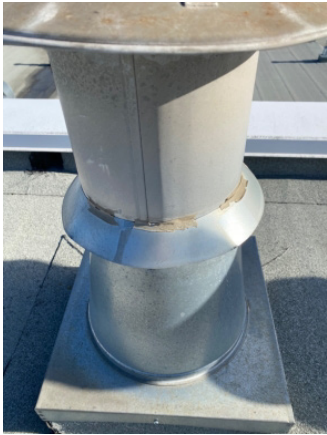
Caulking is either non-existent or is in need of cleaning and applying.

Clean and prep area and apply new caulking.

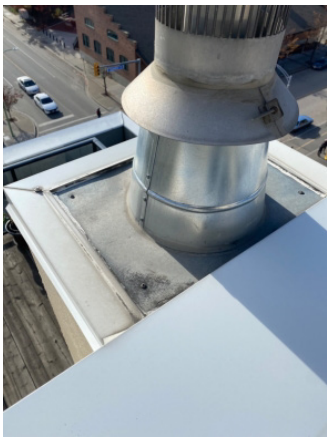
Add Liquid Membrane

Liquid membrane is either non-existent or is in need of cleaning and applying.

Clean and prep area and apply liquid membrane on entire base

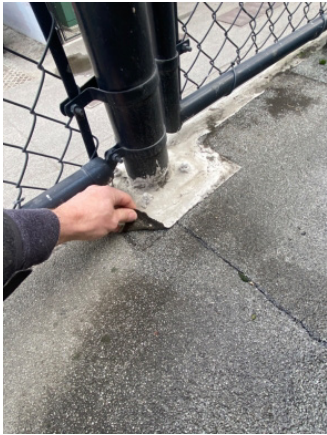
Add Liquid Membrane (Emergency)

Liquid membrane is either non-existent or is in need of cleaning and applying.

Clean and prep area and apply liquid membrane.

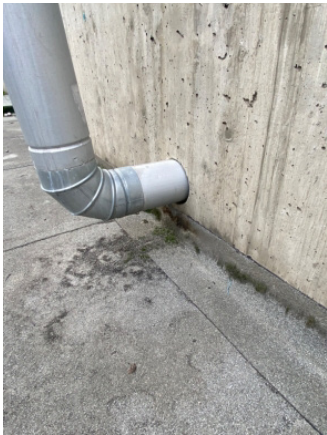
Penetration - Improper installation

The existing pipe penetration was flashed with improper materials

Remove the existing materials and flash the pipe penetration with the manufacturers approved materials and installation procedure.

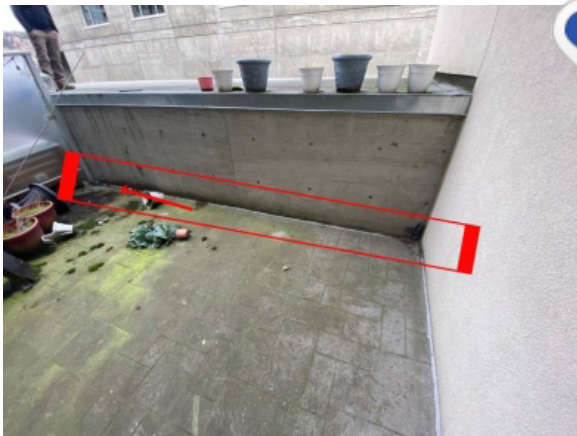
Membrane Failure

The existing membrane flashing has been installed under the minimum required height and is allowing water ingress.

Saw cut into concrete, install PMMA liquid membrane onto concrete deck and up parapet wall 6". Install metal gum lip flashing. May need to cut stucco, stucco not included.

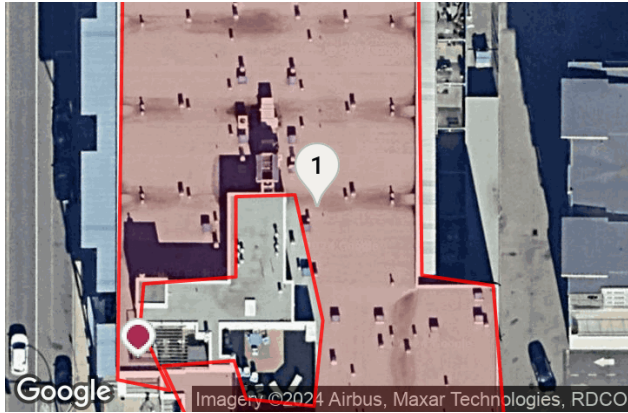
Perimeter - Metal Edge - Loose (Fasteners) (Emergency)

As the building moves and flexes the fasteners will loosen up and eventually back out completely resulting in water infiltration.

A new fastener, one size larger would be installed per industry standards to ensure a water tight seal.

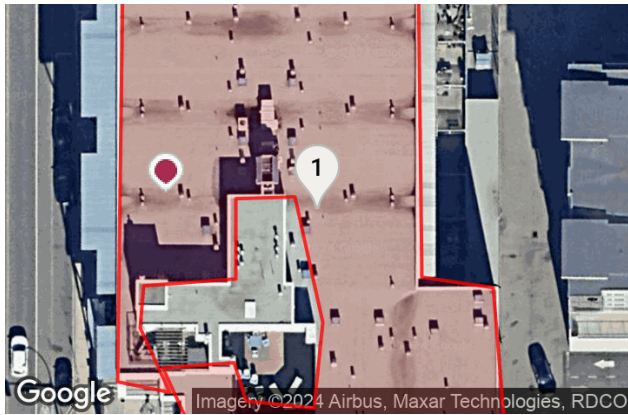
Membrane - Splits/Cracks (Emergency)

Splits/cracks in the membrane are typically due to building movement and lateral stresses. As the membrane ages and weathers, it cannot withstand these forces and split open.

The area surrounding the split must be cleaned and preped. Compatible roofing materials for the existing roof system would be installed according to minimum industry standards.

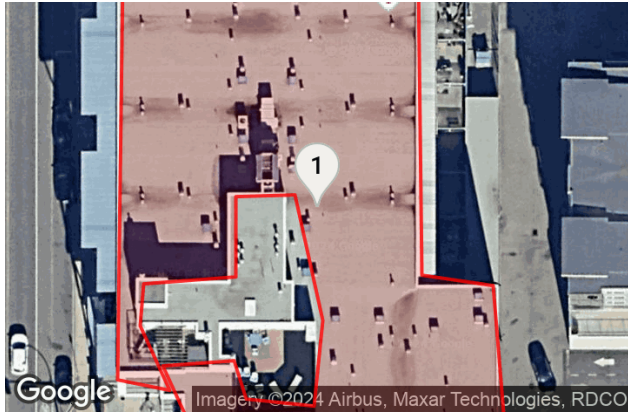
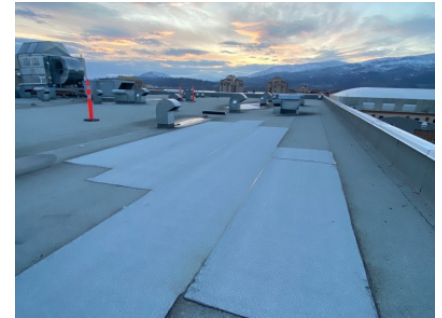
Membrane - Holes (Emergency)

Holes caused by nails backing out of base sheet membrane.

Cut ridge out of membrane, fasten cap sheet membrane, Install new base membrane and New cap sheet membrane as per manufactures requirements.

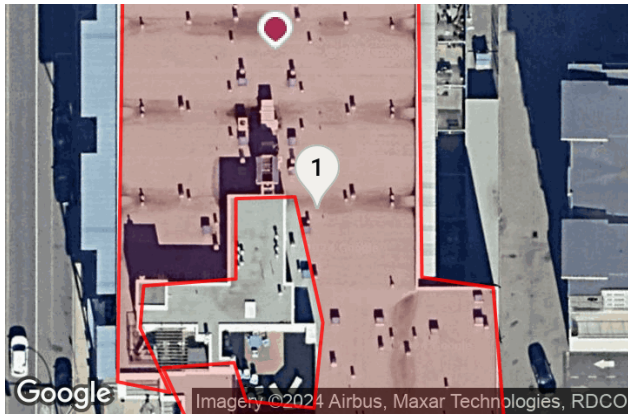
Membrane - Splits/Cracks (Emergency)

Splits/cracks in the membrane are typically due to building movement and lateral stresses. As the membrane ages and weathers, it cannot withstand these forces and split open.

The area surrounding the split must be cleaned and preped. Compatible roofing materials for the existing roof system would be installed according to minimum industry standards.

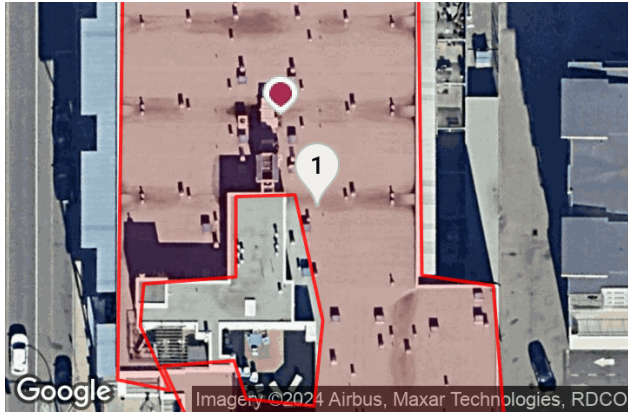
Membrane - Splits/Cracks (Emergency)

Splits/cracks in the membrane are typically due to building movement and lateral stresses. As the membrane ages and weathers, it cannot withstand these forces and split open.

The area surrounding the split must be cleaned and preped. Compatible roofing materials for the existing roof system would be installed according to minimum industry standards.

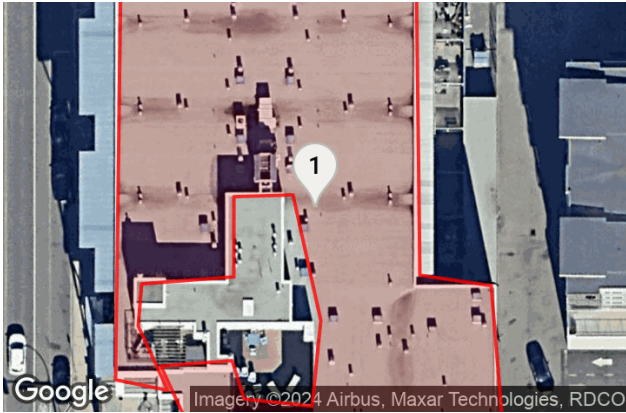
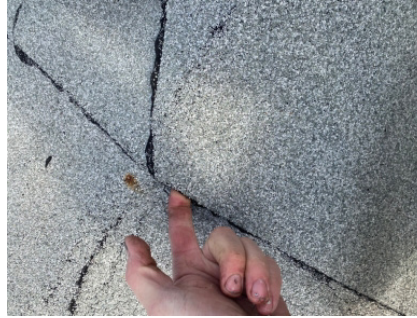
Membrane - Fish Mouth in Corner (Emergency)

Example of fish mouths on membrane laps that is allowing water into the system.

We will cut the fish mouth out, clean and prime the area and install new patch over effected area to ensure water tightness.

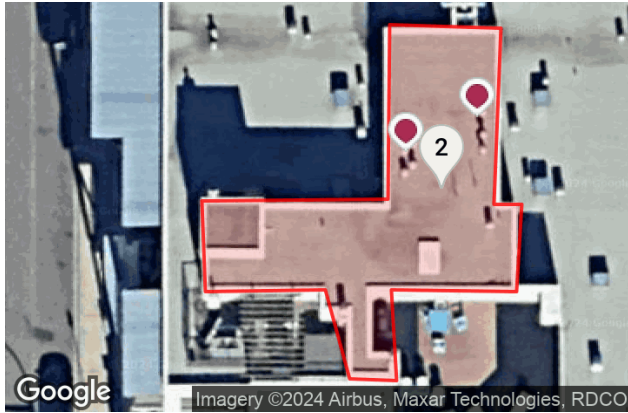
Penetration - Pipe flashing failure (Emergency)

Due to age, weathering, UV &/or improper installation the penetration flashing has failed.

The pipe penetration should be repaired/flashed properly for the type of roof system per minimum industry standards to ensure a water tight seal.

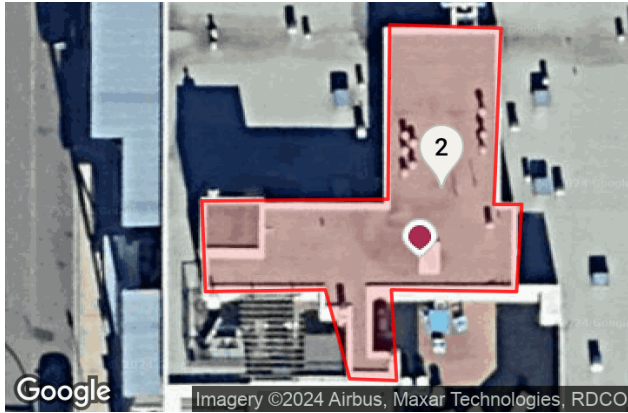
New Metal Cap and counter flashing (Emergency)

Metal cover allows water ingress.

Supply and Install New Solid Metal Cap. Plywood may need to be replaced if rotted out. Plywood not included

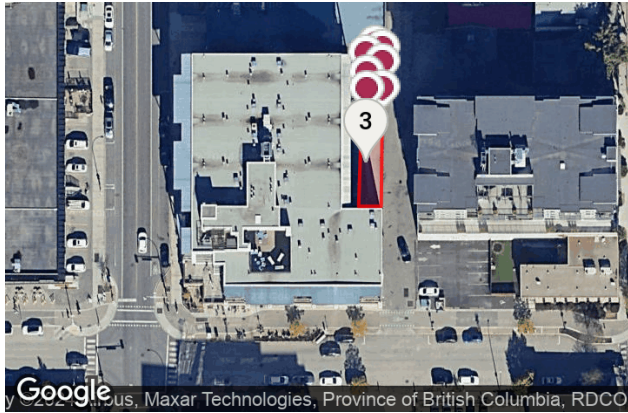
Add Liquid Membrane (Emergency)

Liquid membrane is either non-existent or is in need of cleaning and applying.

Clean and prep area and apply liquid membrane
