Inspection Report

Section: Main Roof

Overall Grade: A-

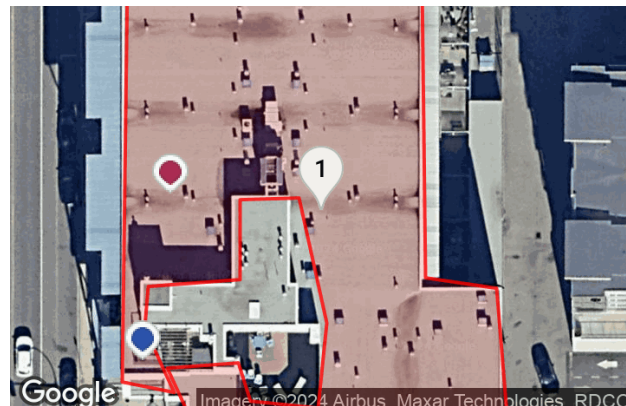
Perimeter - Metal Edge - Loose (Fasteners) (Emergency)

As the building moves and flexes the fasteners will loosen up and eventually back out completely resulting in water infiltration.

A new fastener, one size larger would be installed per industry standards to ensure a water tight seal. **Estimated Repair Cost:**

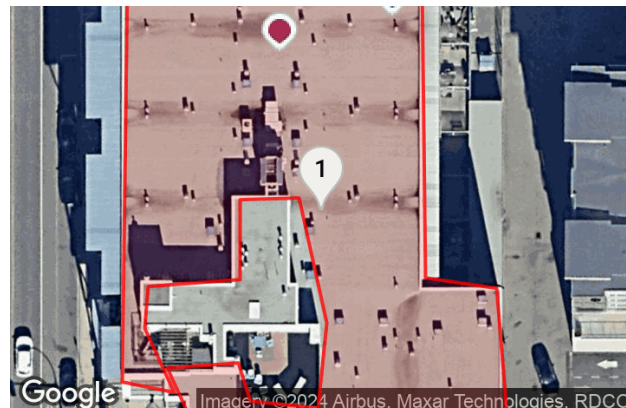
Membrane - Holes (Emergency)

Holes caused by nails backing out of base sheet membrane.

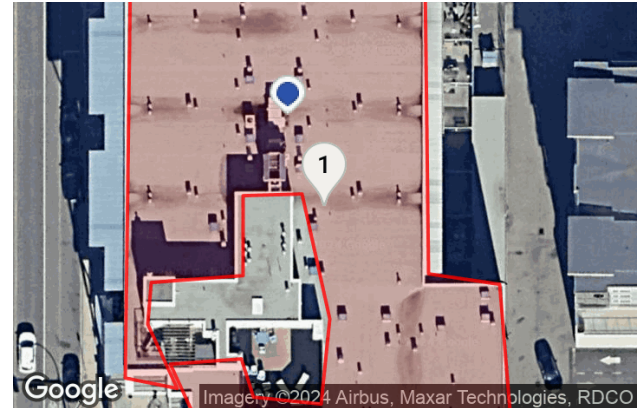
Membrane - Splits/Cracks (Emergency)

Splits/cracks in the membrane are typically due to building movement and lateral stresses. As the membrane ages and weathers, it cannot withstand these forces and split open.

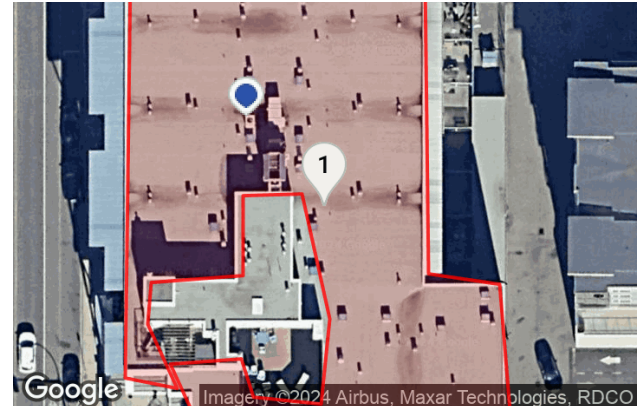
New - Curb Installation

Supports need to be installed under rooftop unit to limit damage to roof membrane and allow for positive drainage.

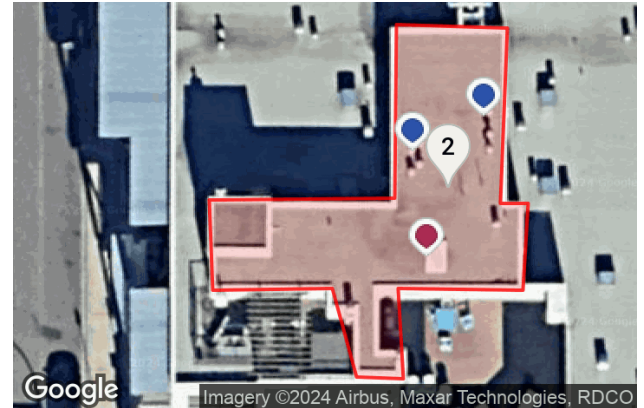
Penetration - Pipe flashing failure (Emergency)

Due to age, weathering, UV &/or improper installation the penetration flashing has failed.

The pipe penetration should be repaired/flashed properly for the type of roof system per minimum industry standards to ensure a water tight seal.
